# Handbook for restoration of eelgrass in Sweden

State of knowledge update 2016-2024

Report 2025-14

Swedish Agency  
for Marine and  
Water Management

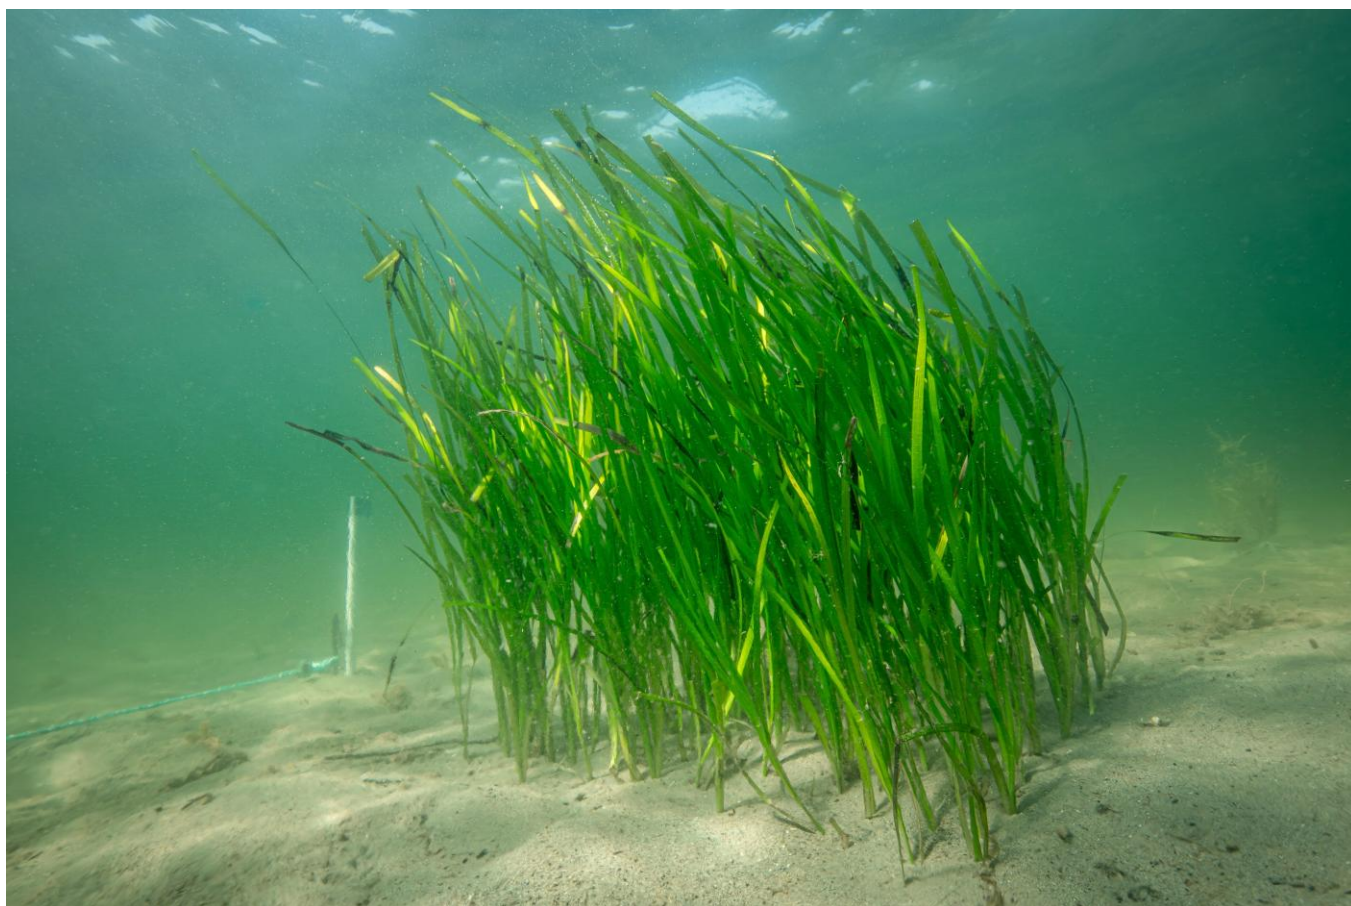
Cover photo: Eduardo Infantes. The image shows densely planted eelgrass shoots at a site in Kosterhavet National Park, where studies are underway to assess whether dense plantings can reduce damage caused by shore crabs.

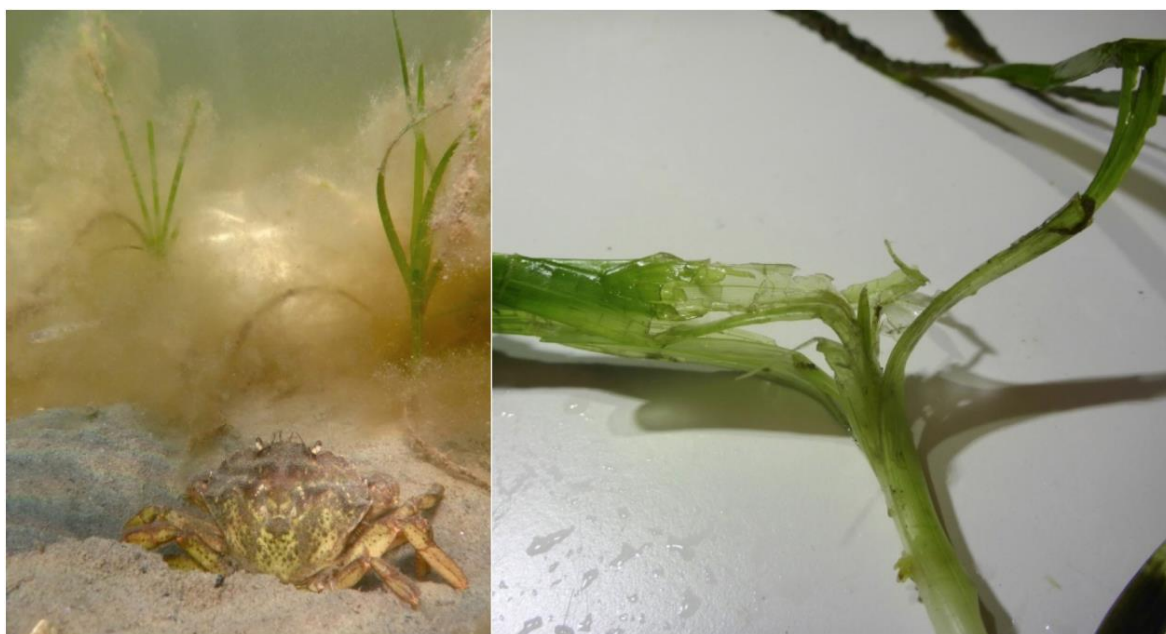
**Figure 4.7.** Image of a shore crab among eelgrass shoots and an example of what damage from a crab can look like.

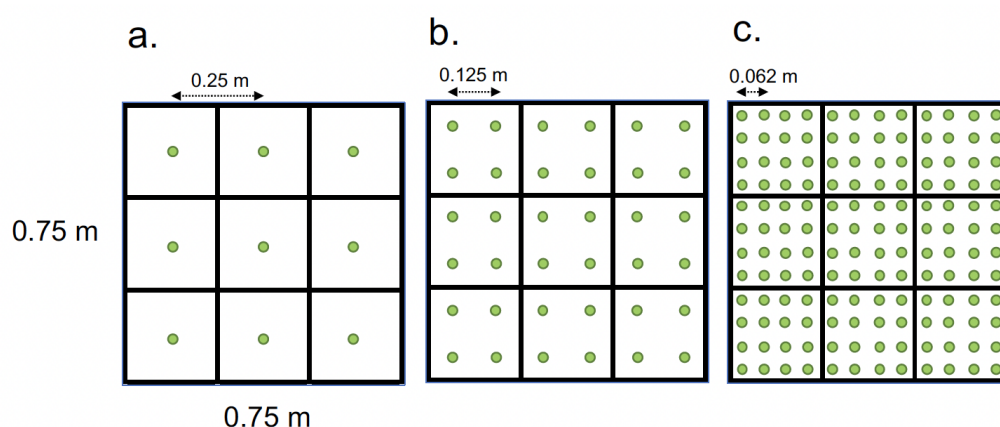
**Figure 4.8.** A schematic illustration of the three shoot densities included in the study on how shoot density affects damage from shore crabs. A) 9 shoots per planting plot, with 25 centimeters spacing (corresponding to 16 shoots per m<sup>2</sup>) B) 36 shoots per planting plot, with 12.5 centimeters spacing (corresponding to 64 shoots per m<sup>2</sup>) C) 144 shoots per planting plot, with 6.25 centimeters spacing (corresponding to 256 shoots per m<sup>2</sup>).

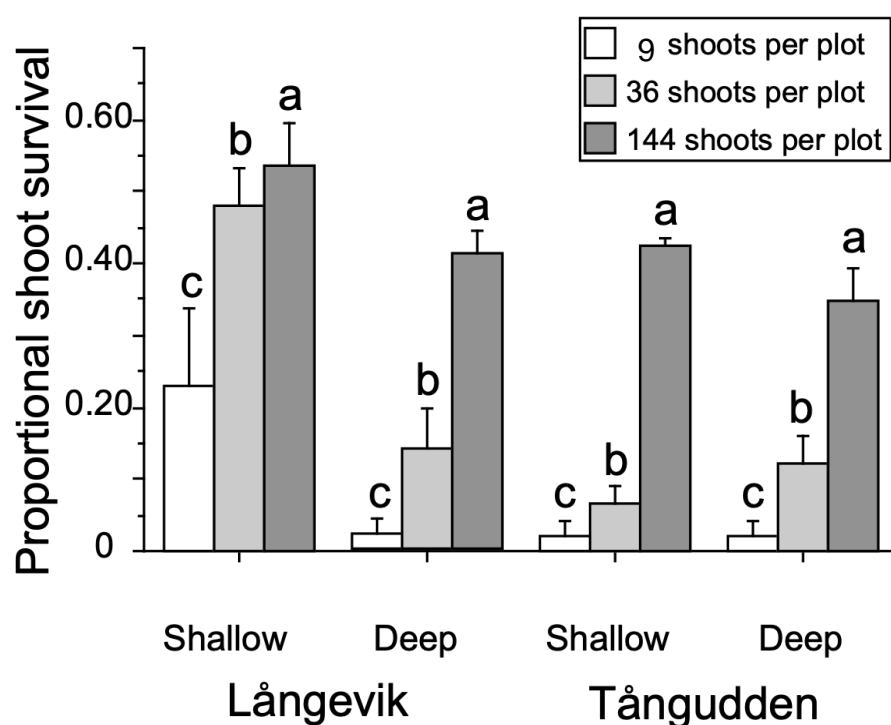
**Figure 4.9.** Results from plantings in Kosterhavet in 2023 showing proportional shoot survival for the three shoot densities (9, 36, and 144 shoots per plot) at the shallow and deep planting sites in Långevik and Tångudden. Different letters above the bars indicate significant differences.

The results showed extensive crab damage to shoots in all treatments, but the proportion of damaged shoots decreased, and the proportion of surviving shoots increased significantly from 7% to 43% as shoot density increased from 16 to 256 shoots per m<sup>2</sup> (Figure 4.9). The effect of fishing was more limited, as the number of crabs caught per day increased at both sites from August to October, despite more than 2,600 crabs being removed from Långevik through fishing. However, the total survival of planted shoots was slightly higher in Långevik than in Tångudden (30% and 17%, respectively), which could indicate that trap fishing had some effect on the number of crabs in Långevik (Infantes unpublished data). During a revisit to the plantings in June 2024, surviving shoots were found only in areas planted with the highest density, further supporting the hypothesis that planting at high densities reduces damage from shore crabs.

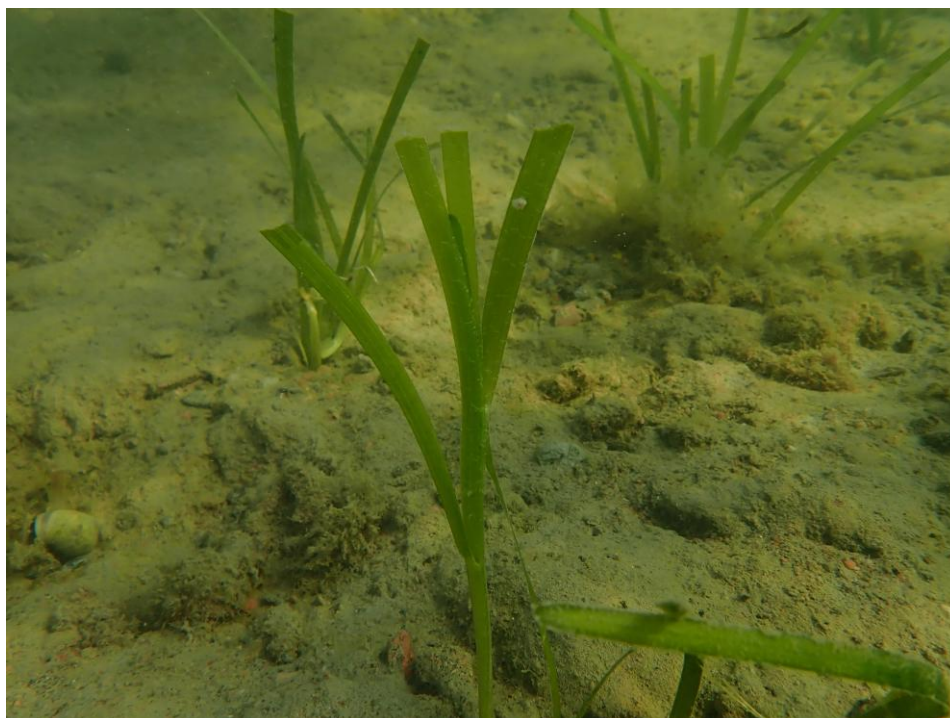
**Figure 4.11.** The image shows planted eelgrass shoots with typical damage from swans. Photo: Anna Feuring.

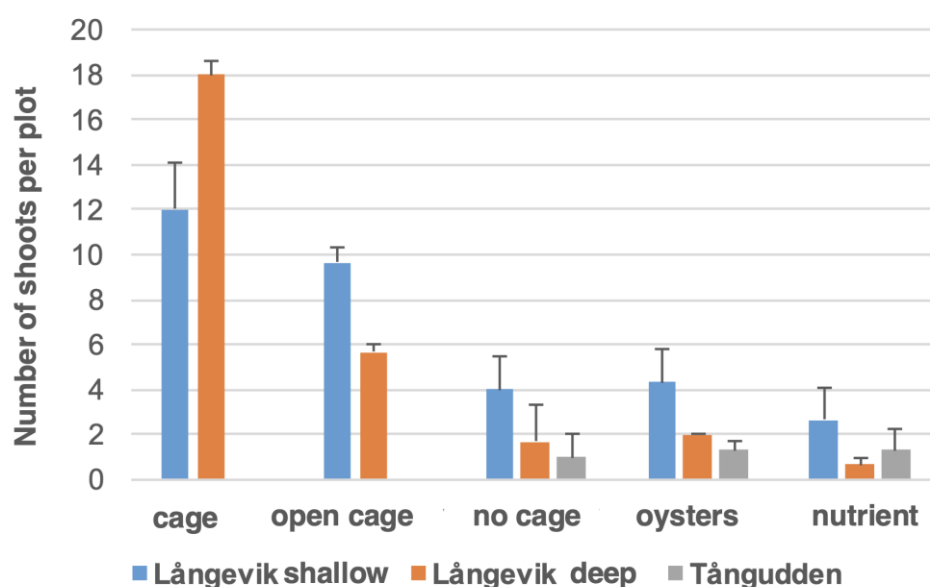
**Figure 4.14.** Results from the field experiment at South Koster in 2021. Mean number of shoots per plot (+SE) in different treatments after 3 months at two different depths in Långevik, as well as at Tångudden (at South Koster).

The experiment lasted for three months (June 29 to September 29, 2021), and when the experiment ended, both the number and length of shoots differed significantly between the cage treatments, but not between the different depths. In the closed cages, long, healthy shoots were found, without damage, and shoot density had increased to an average of 15 shoots (Figures 4.14, 4.15). In the cage treatments with holes, significantly fewer shoots were found (an average of 8 shoots), and many shoots showed crab damage with cut shoots and shoot tips floating at the top of the cage. Very few shoots were found in the treatments without cages (an average of 1.7–3.2 shoots), which did not differ from each other (Figure 4.14). Surviving shoots in the treatments without cages were in very poor condition, with short leaves, many showing damage from crabs and tube-building polychaetes (Figure 4.15, see section 4.4), or were heavily overgrown by, among others, colonial sea squirts (Figure 4.13c).

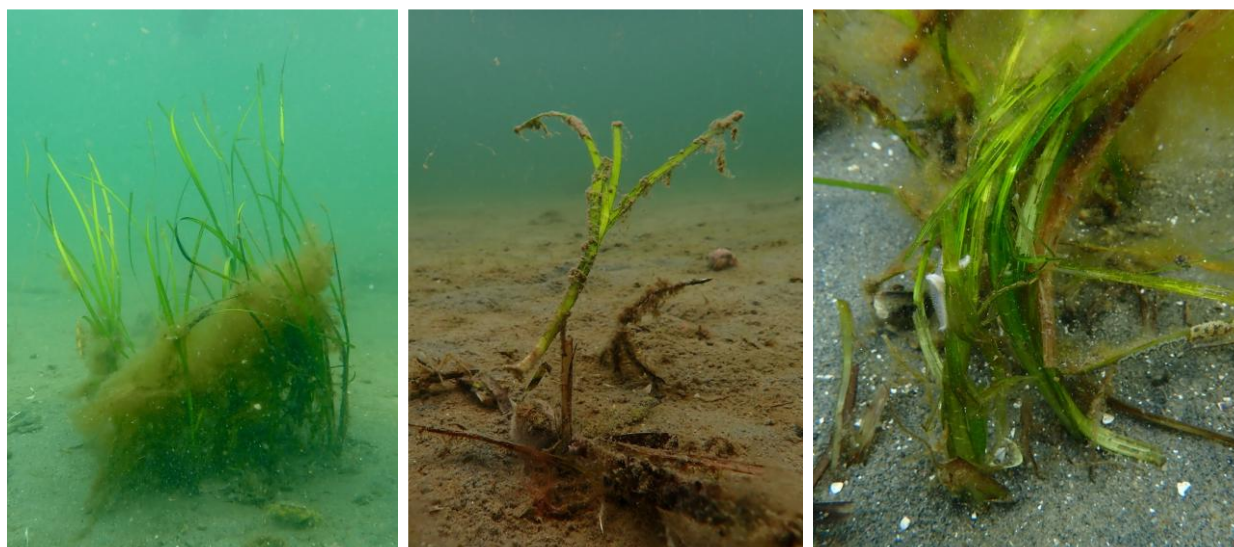
**Figure 4.15.** Photos from the conclusion of the field experiment in Långevik on September 29, 2021. On the left are eelgrass shoots that grew inside a closed cage for 3 months, with long (70 centimeters) healthy leaves without damage. In the center and on the right are typical shoots that grew without a cage, with short (20–30 centimeters) leaves showing various types of damage from crabs and polychaetes that build nests from cut leaves. Photo by Per Moksnes

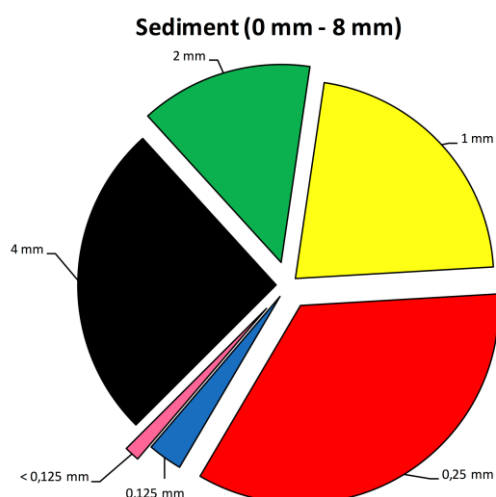
**Figure 5.1.** Grain size of the sediment used for sand capping (drainage gravel 0–8 mm) at Lilla Askerön in southern Bohuslän.

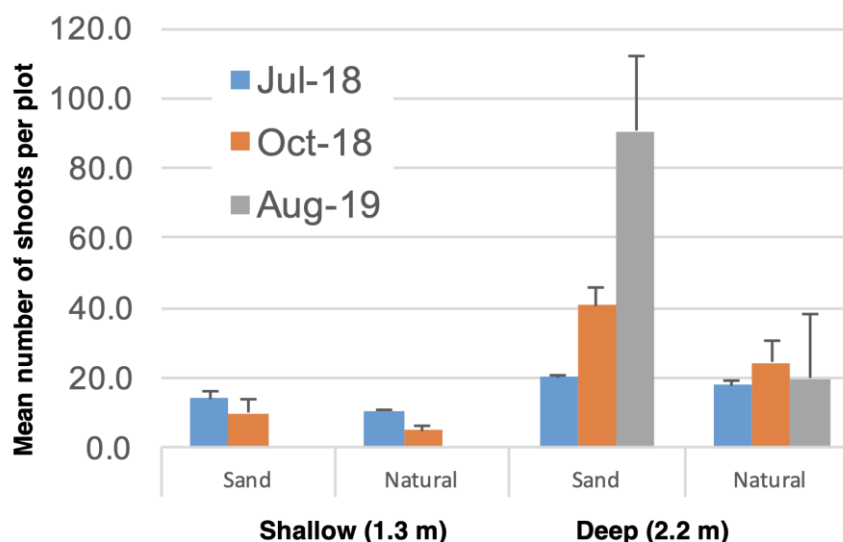
**Figure 5.3.** Mean number of shoots per plot (+SE) in eelgrass test plantings at Lilla Askerön, where 16 shoots per m<sup>2</sup> were planted on deposited sand and on natural sediment in June 2018 along the shallow (1.3 meter) and the deep (2.2 meter) transects in the bay. The photo on the right shows the positions of the transects.

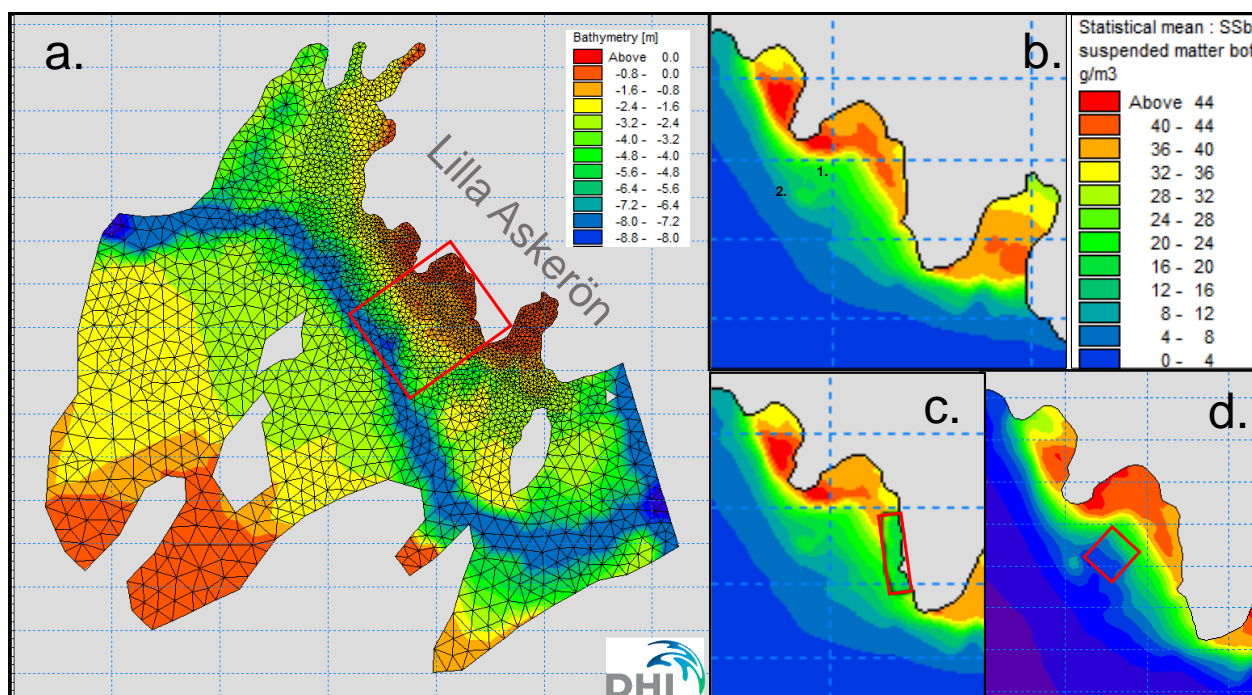
**Figure 5.4.** (a) High-resolution three-dimensional hydrodynamic circulation model for the area around Lilla Askerön, used to simulate the effect of sand capping on sediment turbidity. (b) Simulated average concentrations of suspended sediment (g/m<sup>3</sup>) in the bay over the summer months. (c) Example of a model simulation of the effect where one hectare of sand has been placed closest to shore (red box), and (d) when one hectare has been placed in the middle of the bay at a depth of 1.3–2.0 meters.

For the work at Lilla Askerön, a high-resolution three-dimensional hydrodynamic circulation model was used for the area around Lilla Askerön, driven by a large-scale hydrodynamic model of southern Bohuslän. The modelling, conducted in collaboration with DHI, was used to simulate the effect of sand capping on sediment turbidity and light conditions in the bay in order to select the optimal location and size (Figure 5.4ab). The results showed that the optimal location for placing one hectare of sand to improve the average light conditions in the entire bay was in shallow water along the shoreline (Figure 5.4c), while the optimal location for improving light conditions at depths where eelgrass could grow long-term (>1.2 meters) was more central in the bay (Figure 5.4d). The modelling results indicated that one hectare of sand capping at the selected location would reduce turbidity sufficiently for eelgrass to grow at the site.

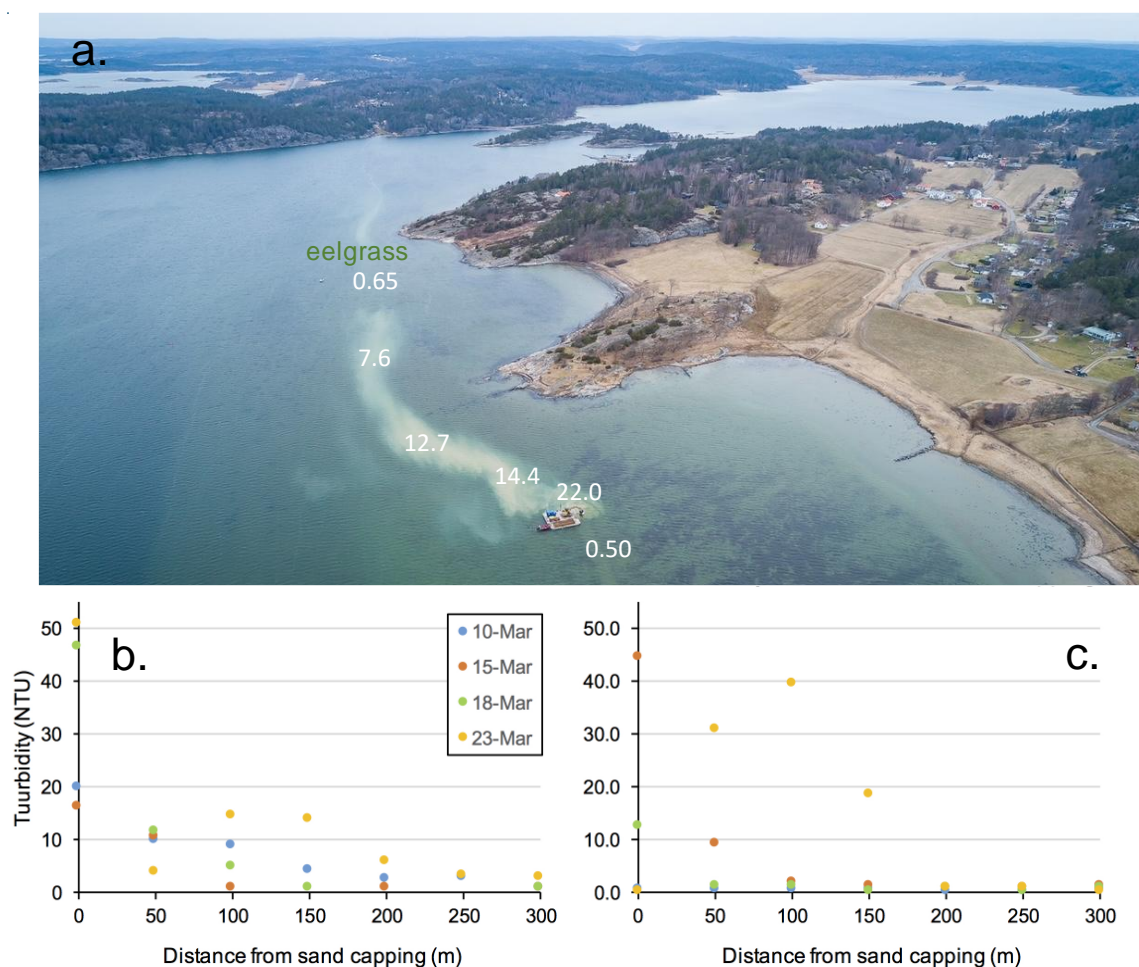
**Figure 5.6.** Results from turbidity measurements (NTU) in surface water during sand covering work at Lilla Askerön in March 2021. (a) Drone image of a sediment plume being transported toward an eelgrass meadow 300 meters north of the sand placement site, with measured turbidity values indicated at approximate locations. Measured turbidity values on four different dates at various distances from the sand covering work in (b) the northern and (c) the southern direction.

High turbidity (up to 50 NTU) was measured at the sand covering site but decreased rapidly with distance. Turbidity values above 10 NTU were never recorded at a distance of 150 meters from the sand covering area. The 15 NTU threshold for turbidity at the eelgrass meadows located 300 meters from the sand covering site was never exceeded (Figure 5.6). In all measurement instances, water circulation was good, and even high turbidity values at the sand covering site returned to background levels within less than 30 minutes after the completion of work.

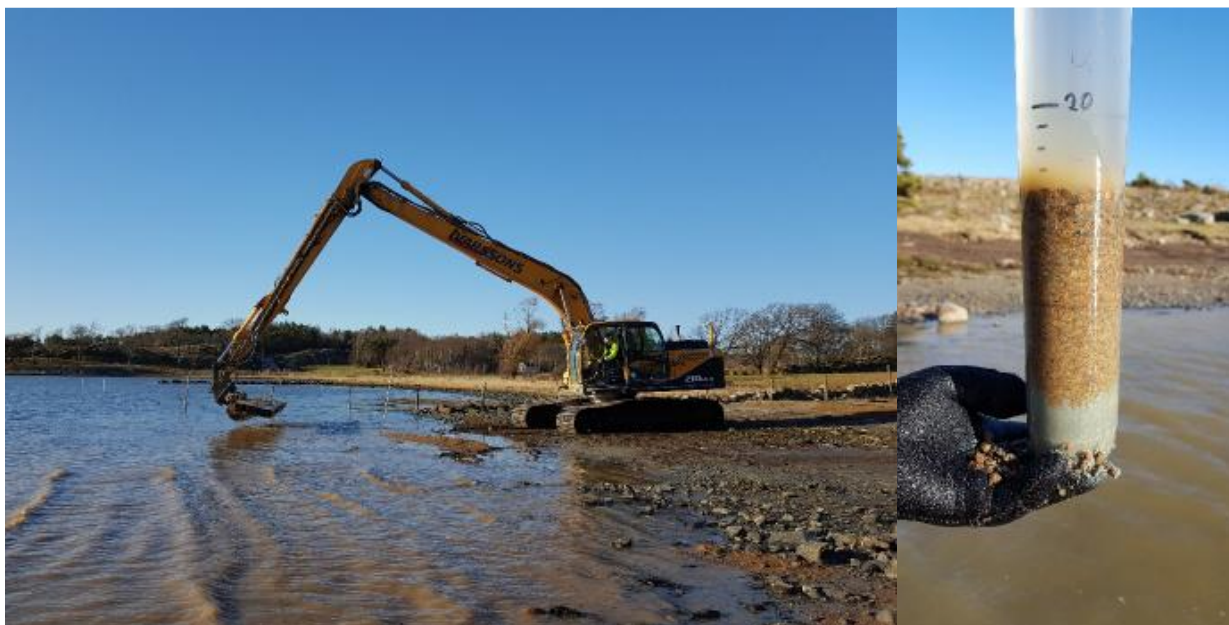
**Figure 5.8.** Sand capping at Lilla Askerön in March 2020 using an excavator from land. The right image shows a sediment sample from the sand-covered area, where the placed sand is clearly visible on top of the natural, muddy sediment.

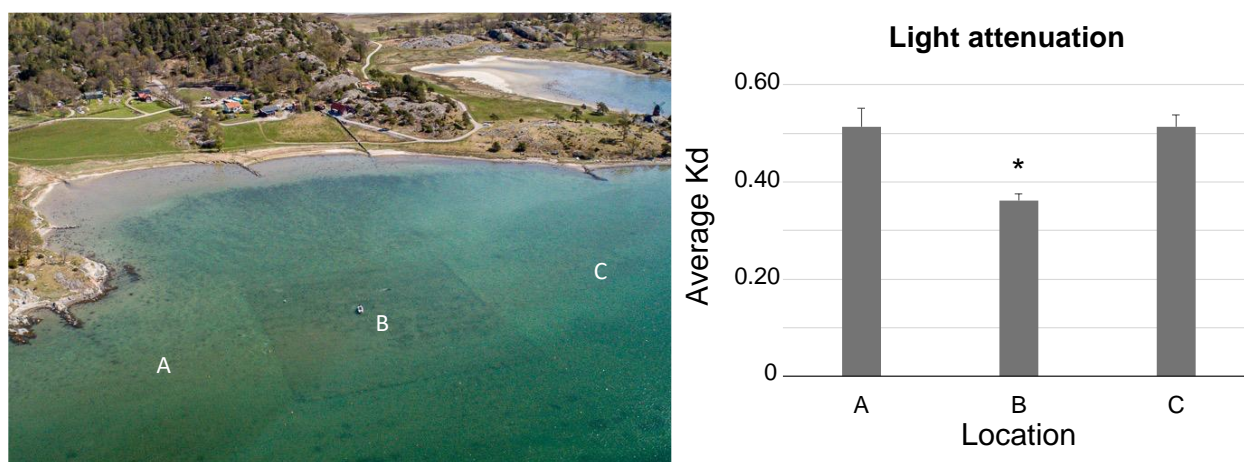
**Figure 5.10.** Results from light measurements at Lilla Askerön in 2023. The aerial photo on the left shows the positions of paired light sensors, with B located in the center of the restored area. The graph shows the calculated average value of the light attenuation coefficient ( $K_d$ ) over a two-week period in late May, where the  $K_d$  value was significantly lower within the sand-capped area.

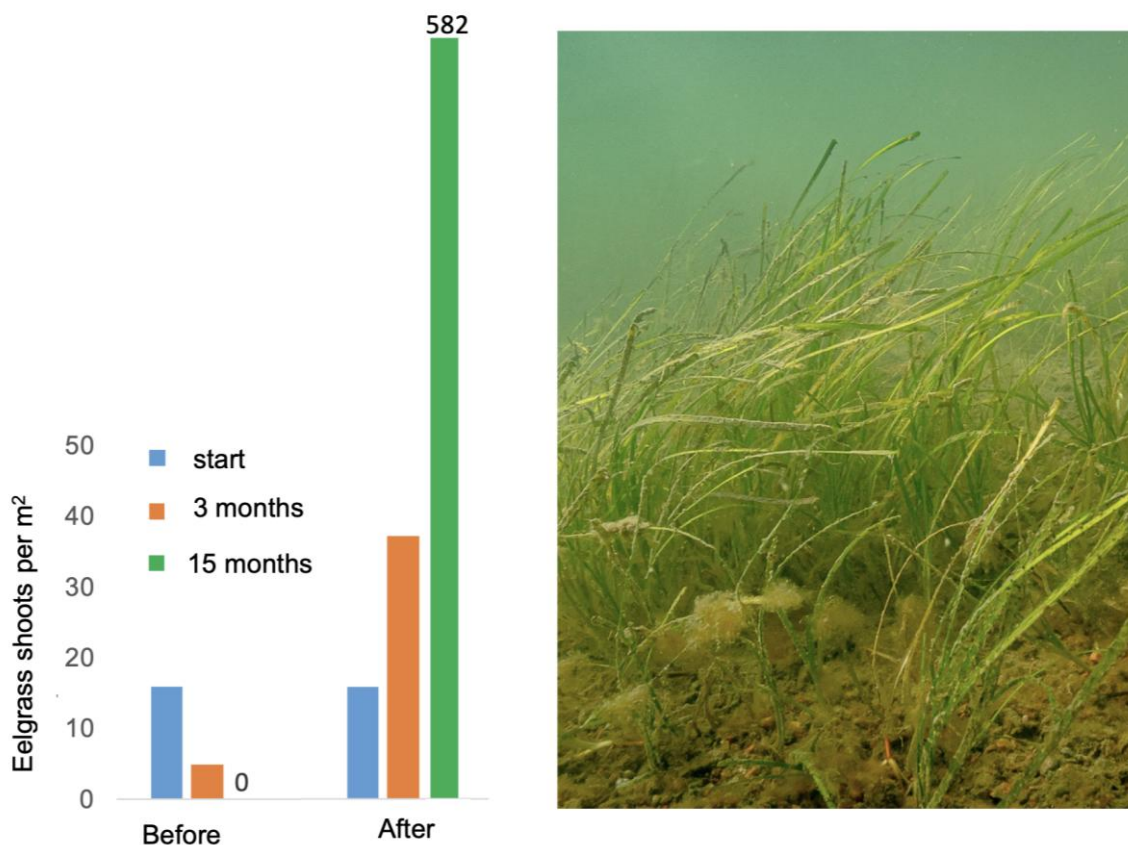
**Figure 5.11.** Growth of eelgrass (16 shoots per m<sup>2</sup>) over 15 months at 1.5 meters depth at Lilla Askerön before sand covering (2018–2019) and after sand covering (2021–2022). The right image shows planted eelgrass in 2022.

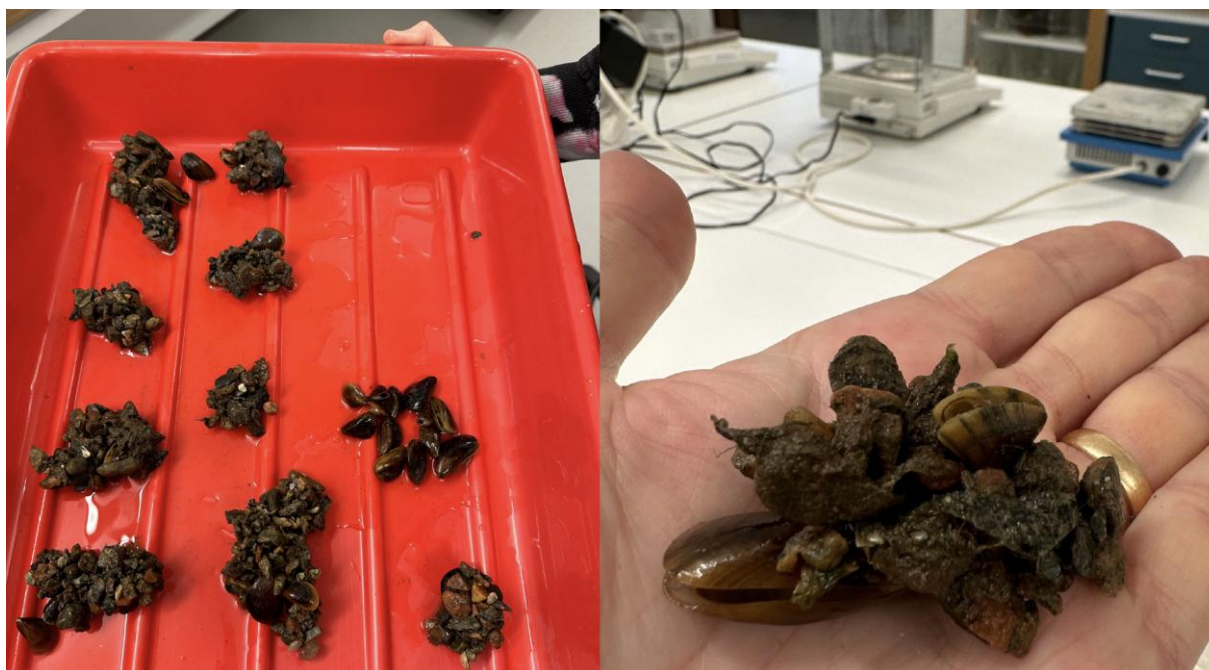
**Figur 5.12.** Examples of "gravel clusters" with juvenile blue mussels found in large numbers in vegetation-free areas of the sand-capped site in October 2023. The gravel clusters are created by juvenile blue mussels attaching their byssal threads to larger gravel particles.
